SUSQUEHANNA RIVER BASIN
BURGOON RUN, BLAIR COUNTY

UPPER KITTANNING DAM

NDI I.D. NO: 530

PHASE I INSPECTION REPORT

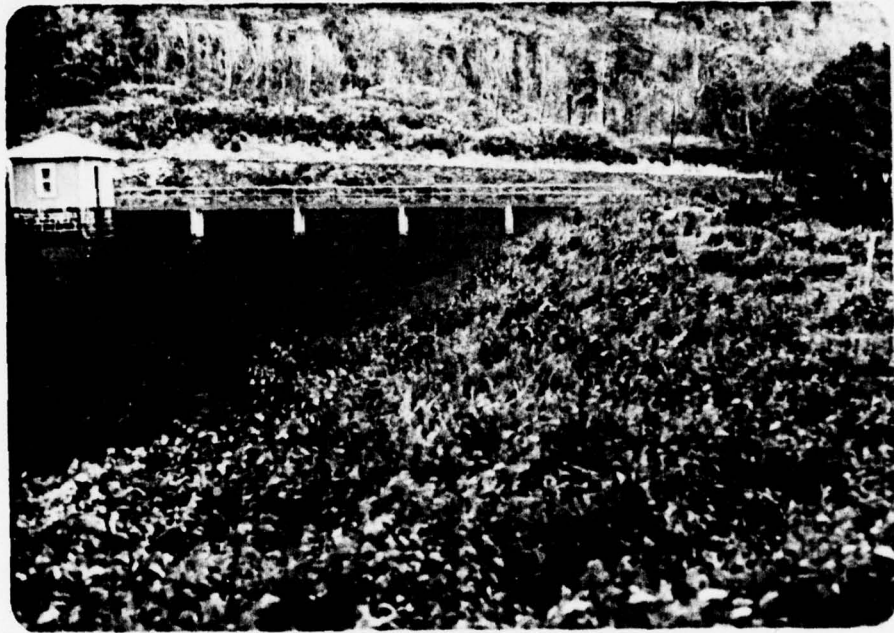
Upstream Face

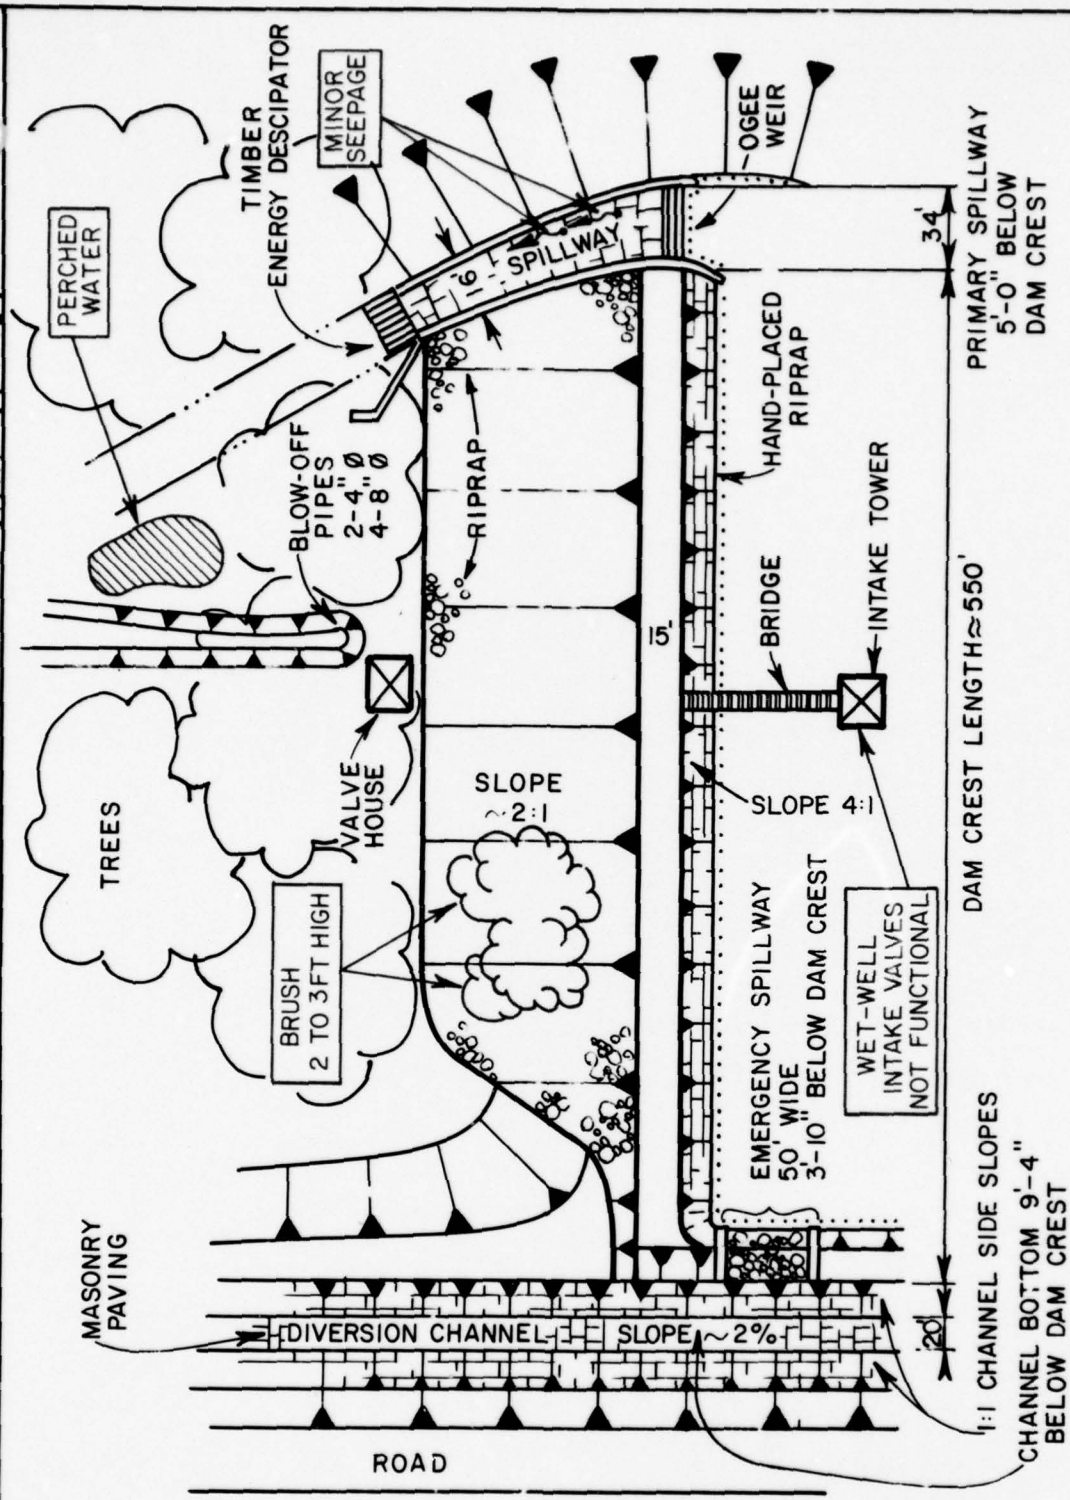
PLATE 7
 UPPER KITTANNING DAM NDI ID:530
 GENERAL PLAN
 FIELD INSPECTION NOTES
 FIELD INSPECTION DATE : AUGUST 8, 1978
D'APOLONIA

VISUAL EXAMINATION OF	OBSERVATIONS	REMARKS OR RECOMMENDATIONS
JUNCTION OF EMBANKMENT AND ABUTMENT, SPILLWAY AND DAM	NO VISUAL SIGNS OF DISTRESS, NO SEEPAGE.	
ANY NOTICEABLE SEEPAGE	PERCHED WATER ABOUT 100-FT DOWNSTREAM OF TOE. NO NOTICABLE SEEPAGE.	SEE PLATE - 7 FOR LOCATION.
STAFF GAGE AND RECORDER	NONE	
DRAINS	NONE

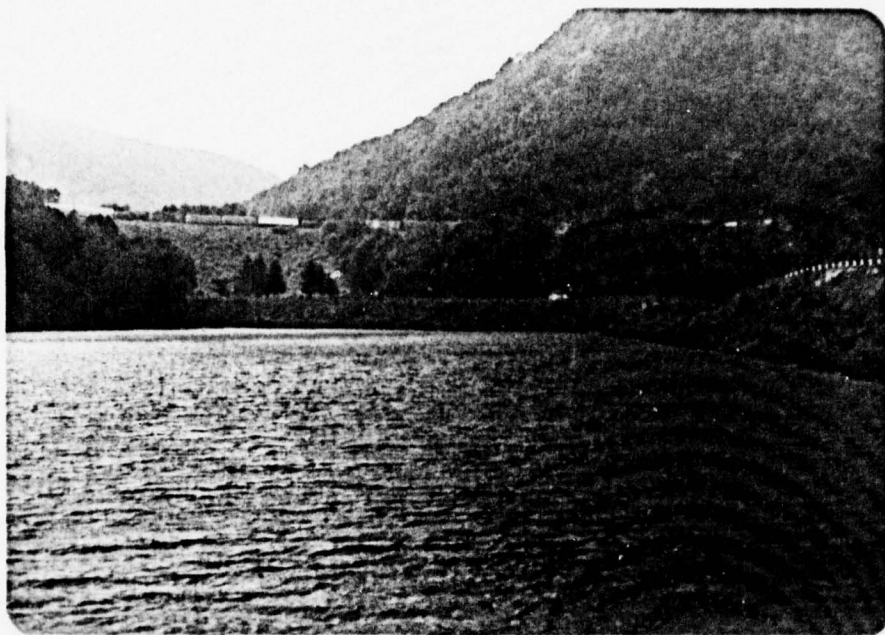
Photograph No. 1
Reservoir (horseshoe curve in background).

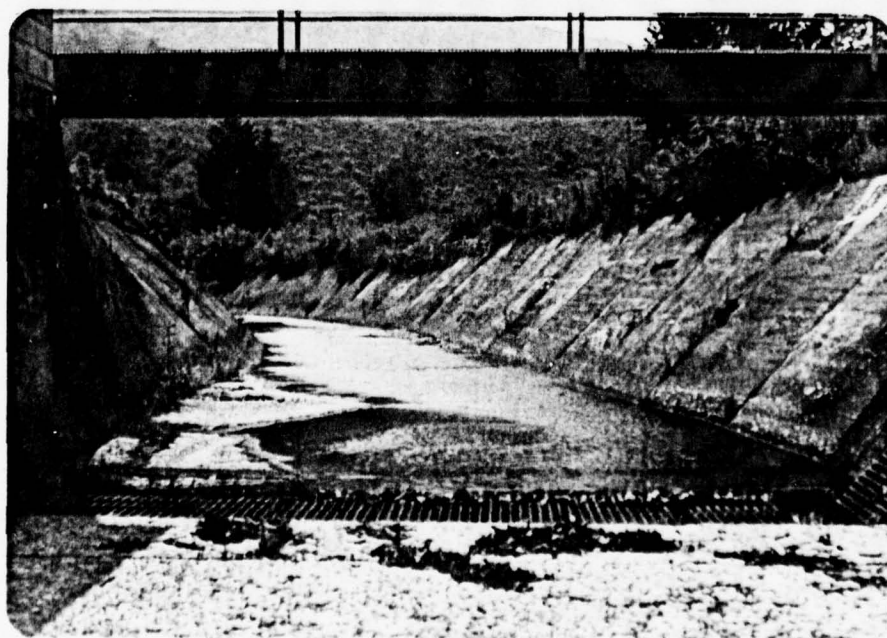
Photograph No. 2
Diversion channel (looking upstream,
foreground reservoir intake).

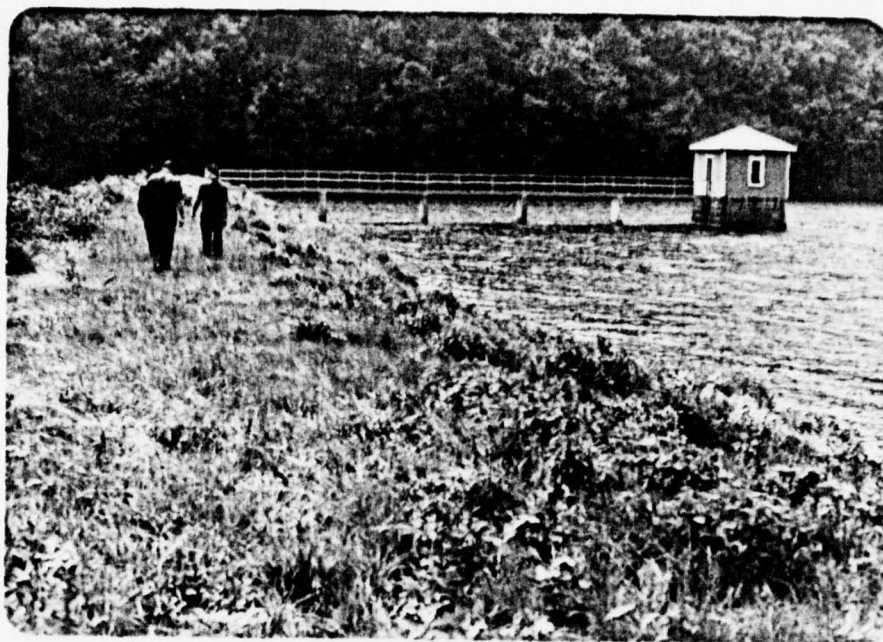
Photograph No. 3
Crest (looking south).

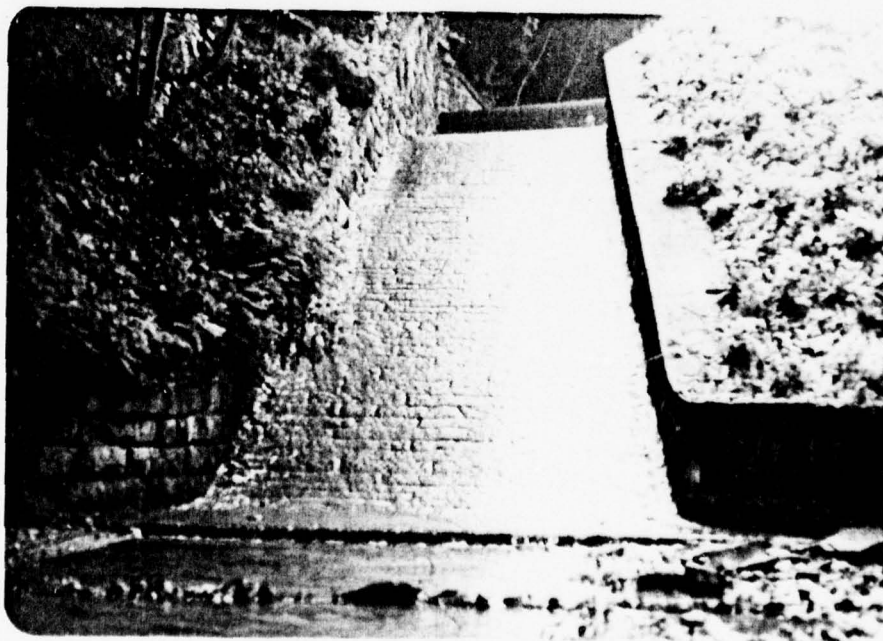
Photograph No. 4
Primary spillway chute.

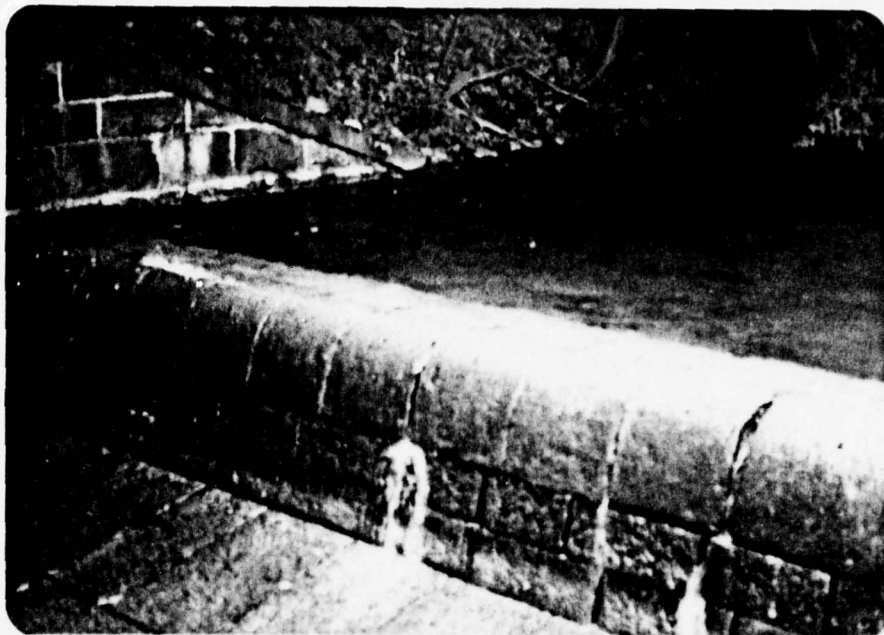
Photograph No. 5
Crest of primary spillway.

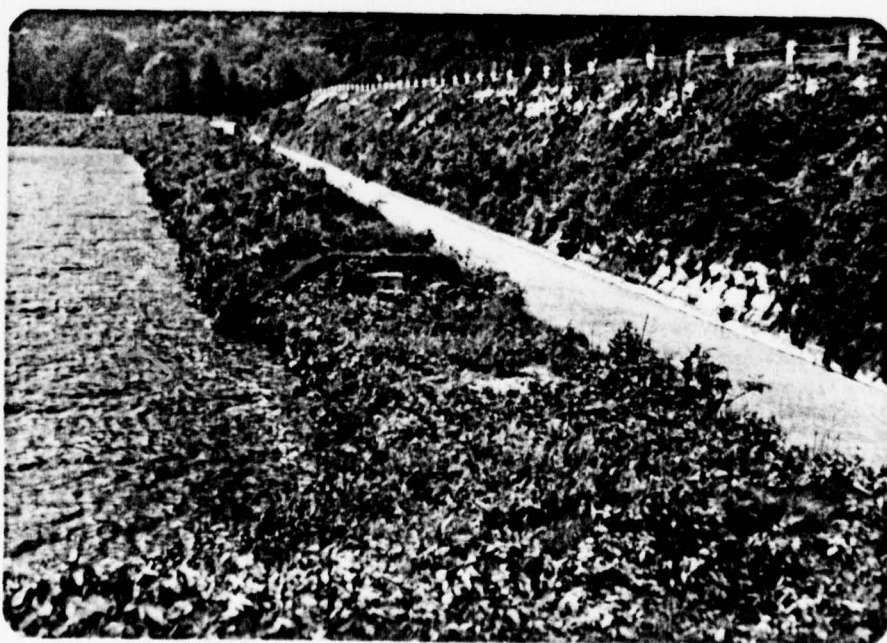
Photograph No. 6
Emergency spillway and diversion channel.

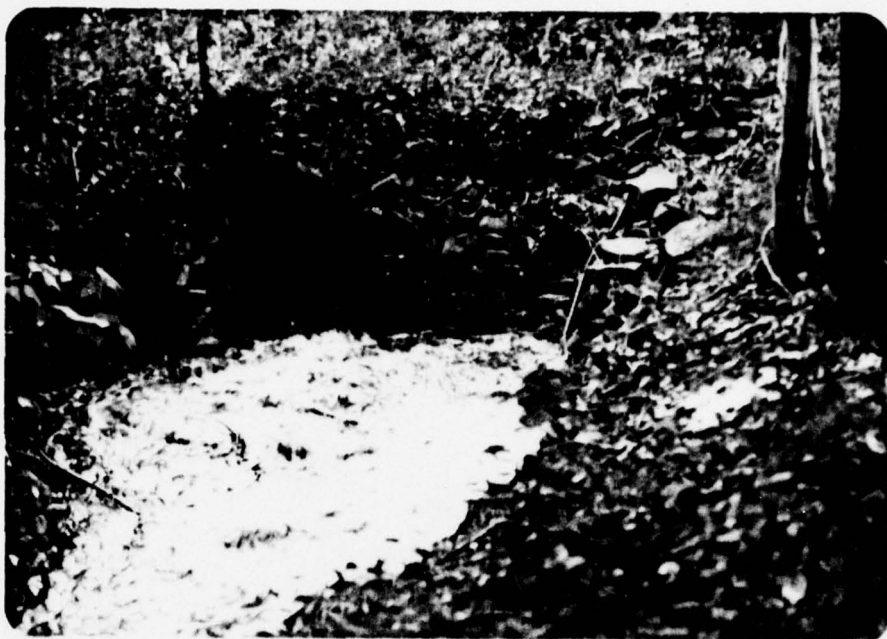
Photograph No. 9
Blow-off pipes discharging.

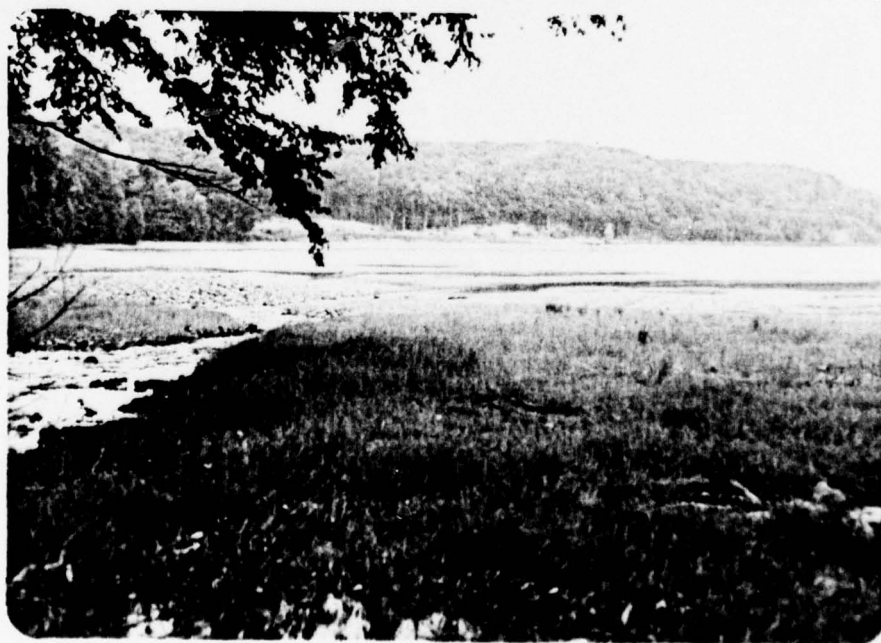
Photograph No. 10
Downstream: Lower Dam.
